## STRUCTURAL STUDY FINDINGS

- Pavement Response **Measured** at Known Temperatures
- Mechanistic Pavement Analysis Approach **Validated**
- Pavement Response **Predicted** at All Temperatures
- Damage (Strains) **Accumulated** with Each Axle Pass
- Mechanistic-Empirical Pavement Design **Calibrated**
- Both 5" Sections Failed (Slightly Later than Expected)
- Fatigue Cracking Now Exists in 7" Sections (Much Later)
- No Cracking Observed in Either 9" Section

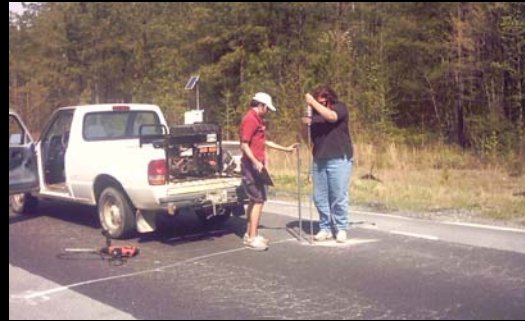
### DYNAMIC CONE TESTING

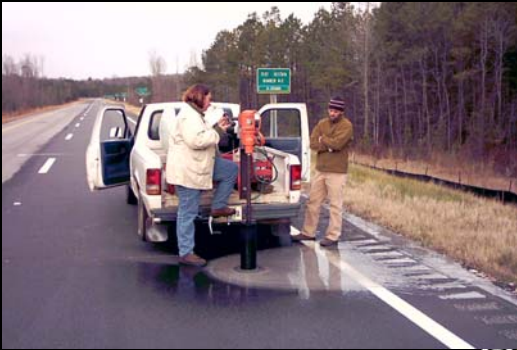
### CORES FOR DYNAMIC MODULI

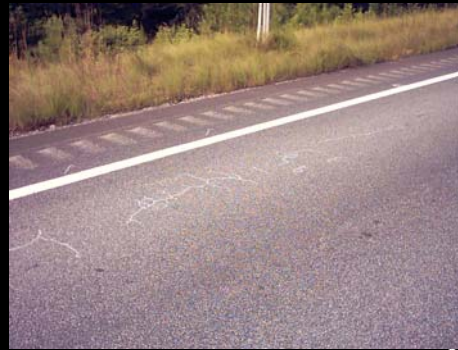
### CORES FOR BOND STRENGTH

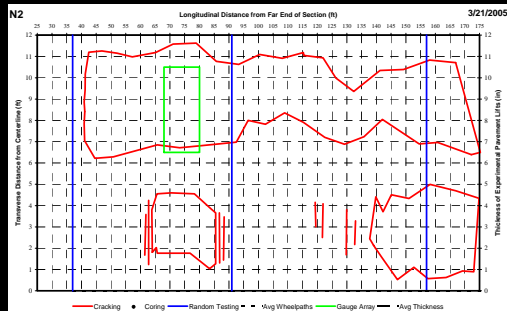
### FINAL CRACK MAPS

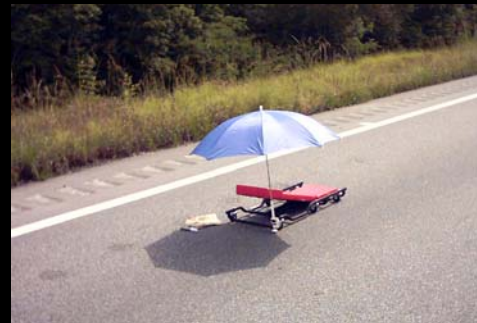
### CRACK MAPPING APPARATUS

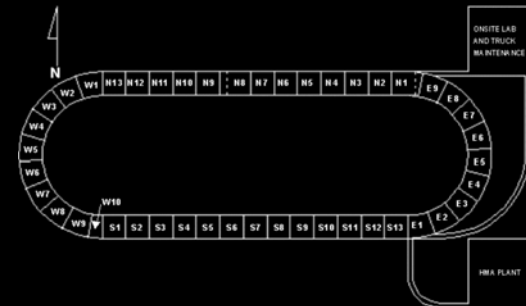
## 2006 TRACK LAYOUT

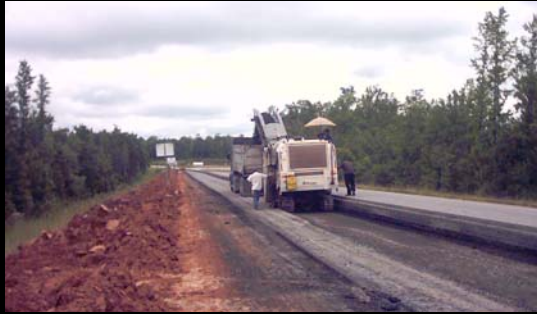
### 2006 STRUCTURAL SECTIONS

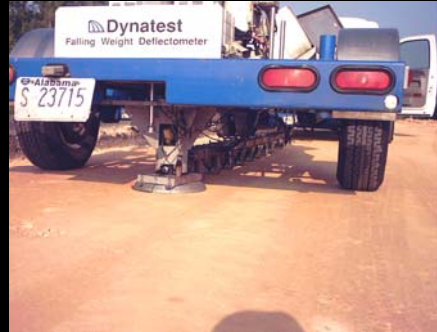
### 2006 BUILDUP CHARACTERIZATION

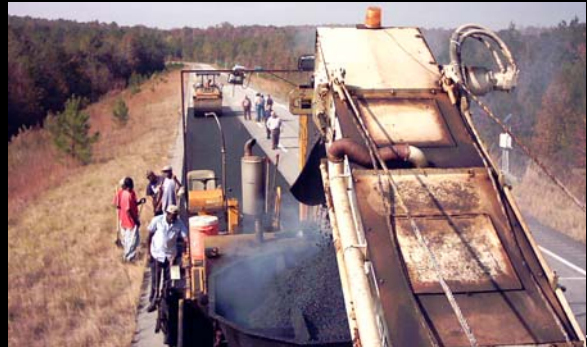
### INSIDE LANE NOISE SECTIONS
