Use of the Overlay Tester for Designing Crack Resistant Asphalt Mixes

2007 SEAUPG
Annual Meeting
Nov. 12-15, 2007
San Antonio, Tx.

Dale Rand, P.E.
TxDOT Construction Division
Flexible Pavements Branch

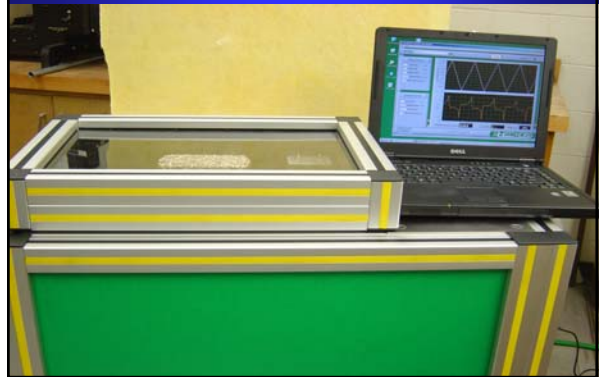
TxDOT's New Overlay Tester

1. Upgrade Hardware and software
2. Fully computer-controlled test

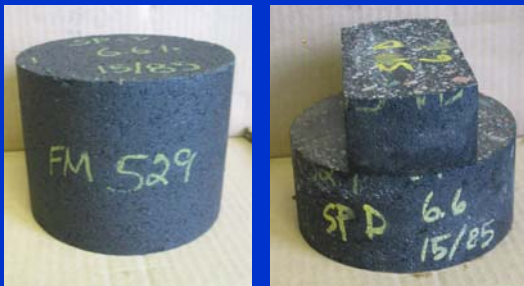
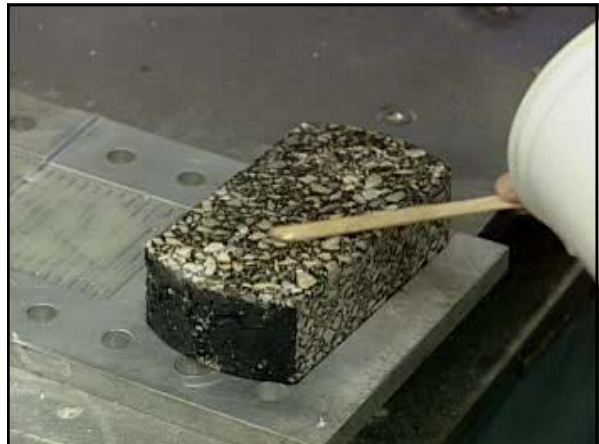
Sample Preparation

- Sample size: 6" long by 3" wide by 1.5" high
 - Loading: Continuously triangular displacement 5 sec loading and 5 sec unloading
 - Standard Test Conditions
