TxDOT
Joint Density Research
&
Specification Development

2007 SEAUPG Annual Meeting

Richard Izzo, PE
TxDOT - Construction Division
Flexible Pavements Branch

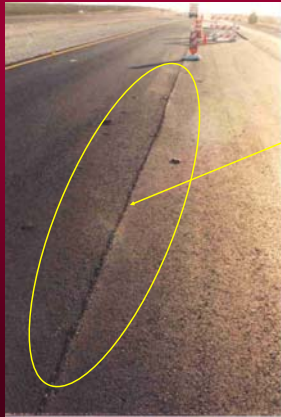
- 3 premature failures in 1999 related to low in-place density along longitudinal joints.
- Premature deterioration of pavement structure.
- Water seeps into pavement structure.
 - ✓ Stripping/moisture damage of HMA.
 - ✓ Saturating base providing poor support.
 - ✓ Cracking & raveling of pavement structure.

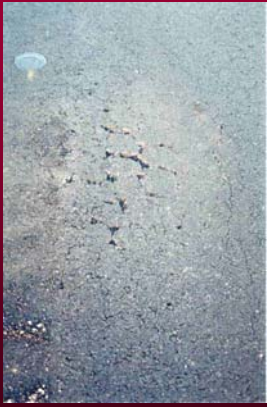
- Poor compaction of longitudinal joint.
- Lip along joint may hold water.
- ~17 percent air voids at the joint and ~10 percent air voids in the main lane.
- GPR testing indicated higher air voids along the joint.

- Cracking evident within a week of construction.
- Other contributing factors.
 - ✓ Heavily trafficked roadway.
 - ✓ Construction during winter months.

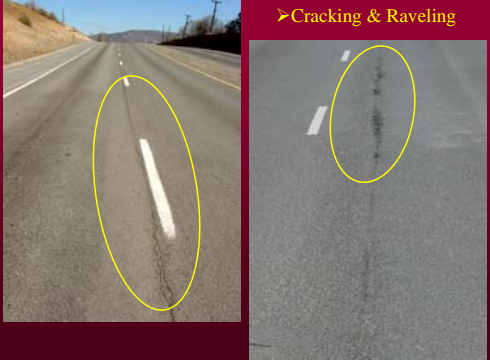
Premature Deterioration

➤ Cracking & Raveling

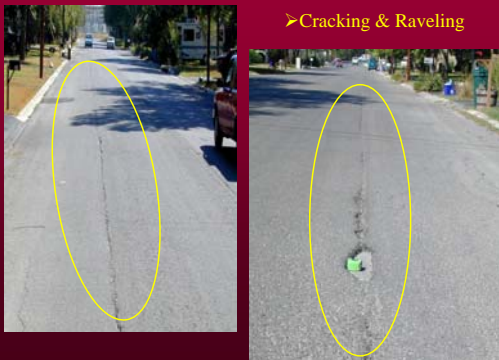
Premature Deterioration

➤ Cracking & Raveling
